[F]IntegraFrame

Dent Screening Assessment Report

L00XX AB-CD

Feature: DNT 8, GW: 3225

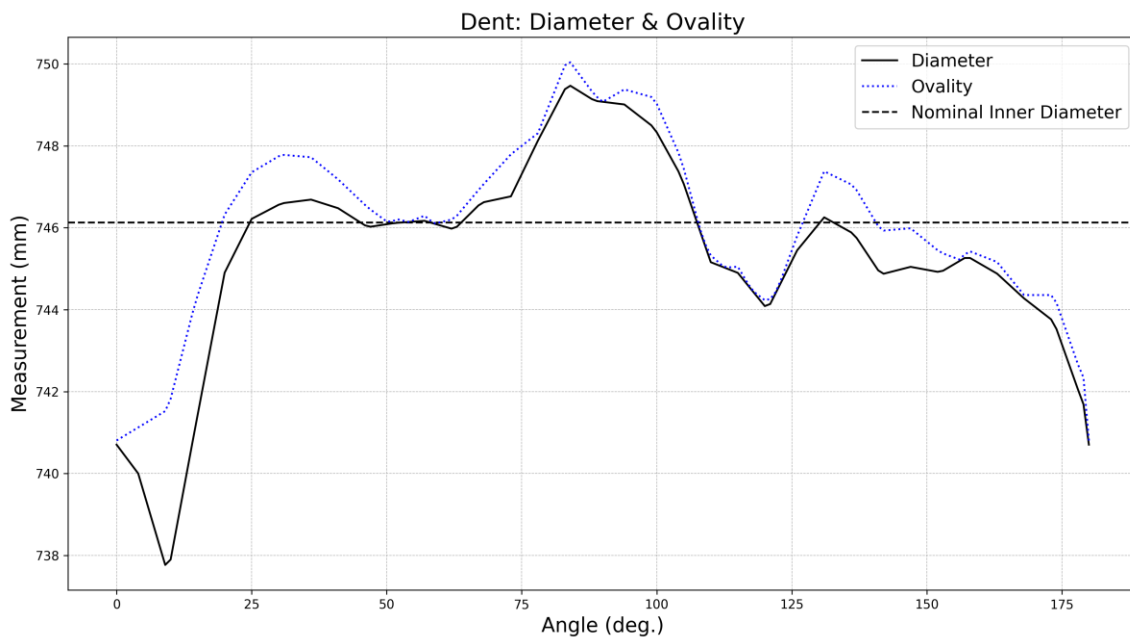
Figure 11: Ovality plot

The feature depth exceeds the ovality depth, meeting the depth criterion. The feature is classified as a dent based on this parameter. The calculated feature ovality is 1.24 %.

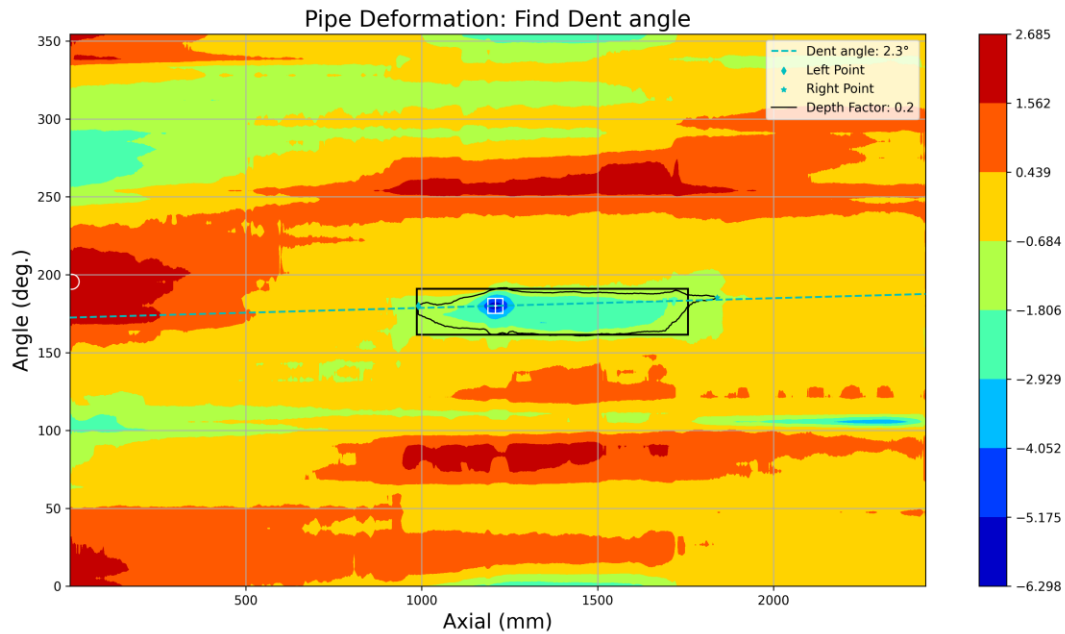
Figure 12: Dent orientation relative to pipe axis

The angle formed between the dent axis and the pipe's longitudinal axis is 2.32°. The dent is NOT classified as off-axis as the orientation angle is less than 30°.

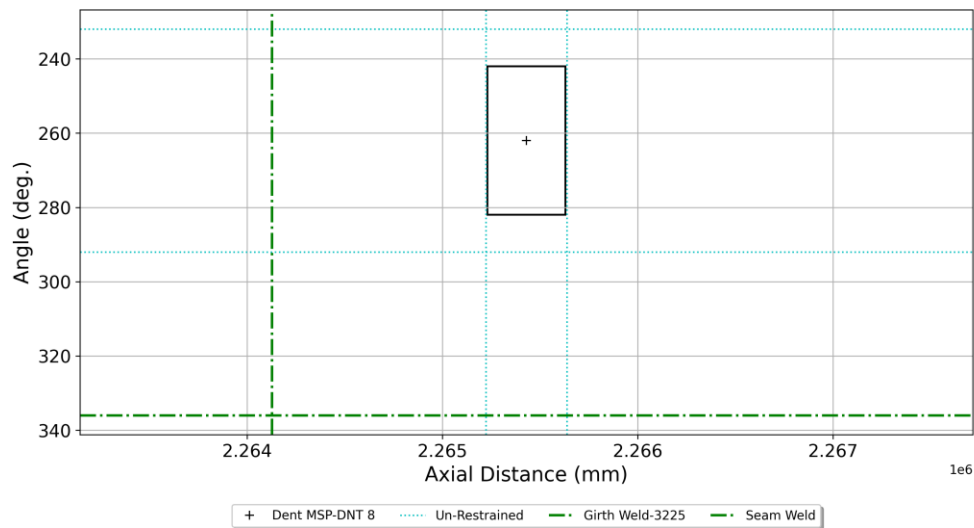
Figure 13: Interacting features

The feature is not interacting with corrosion feature as per API 1183 interaction criterion.

The feature is not interacting with crack feature as per API 1183 interaction criterion.

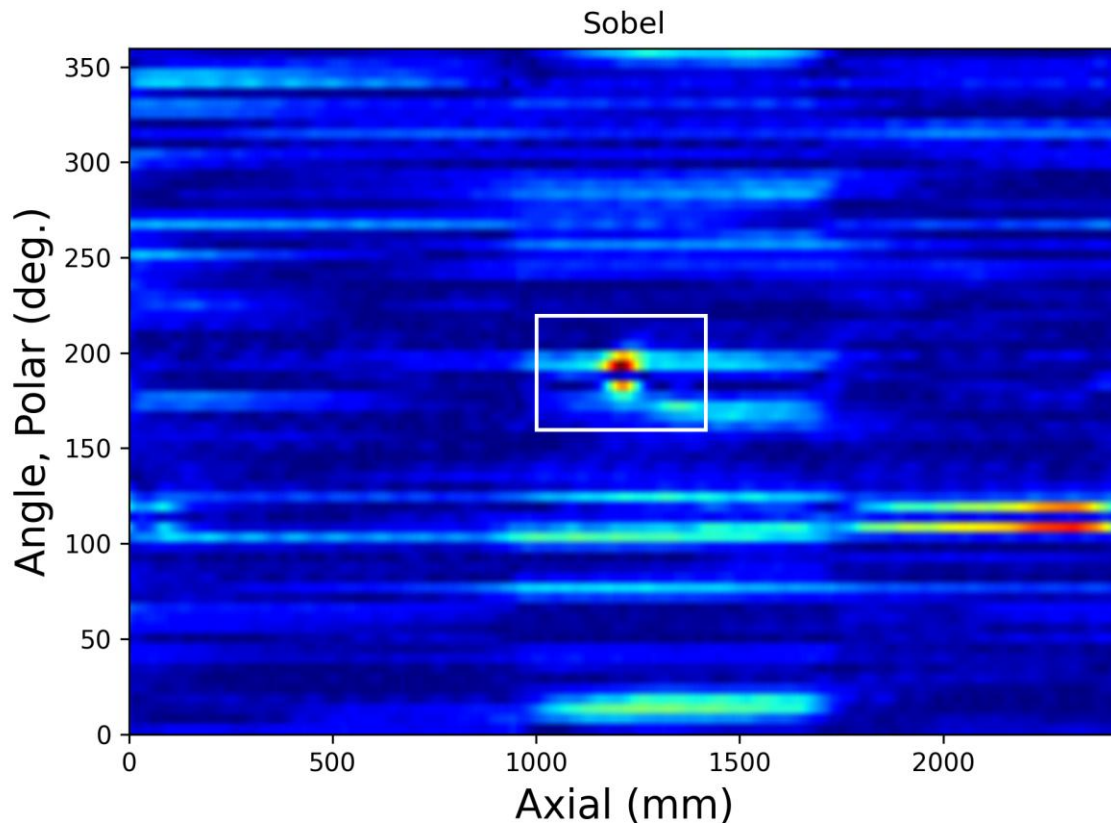
Figure 14: Sobel plot to identify weld interaction

The feature is assessed as NOT interacting with any weld.

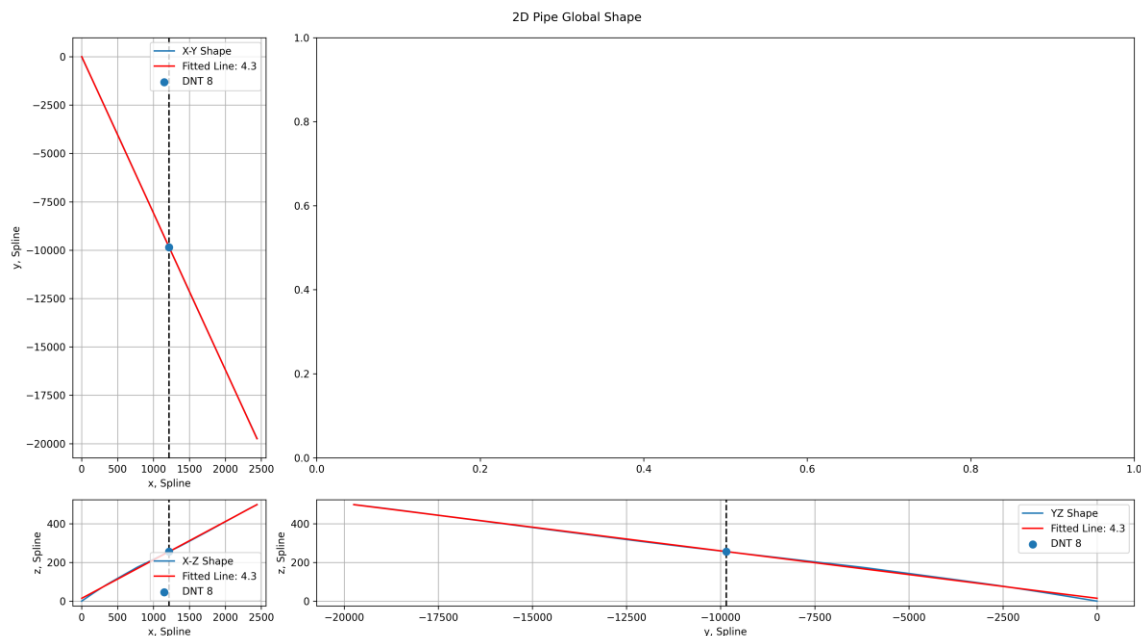
Figure 15: Global pipe shape

Figure 15 depicts the global shape of the pipe derived from the IMU data. The red line represents the best-fit straight line, and the deviation of the pipe from this line is quantified using the root mean square error (RMSE). The straight line deviation is 4.29 mm.

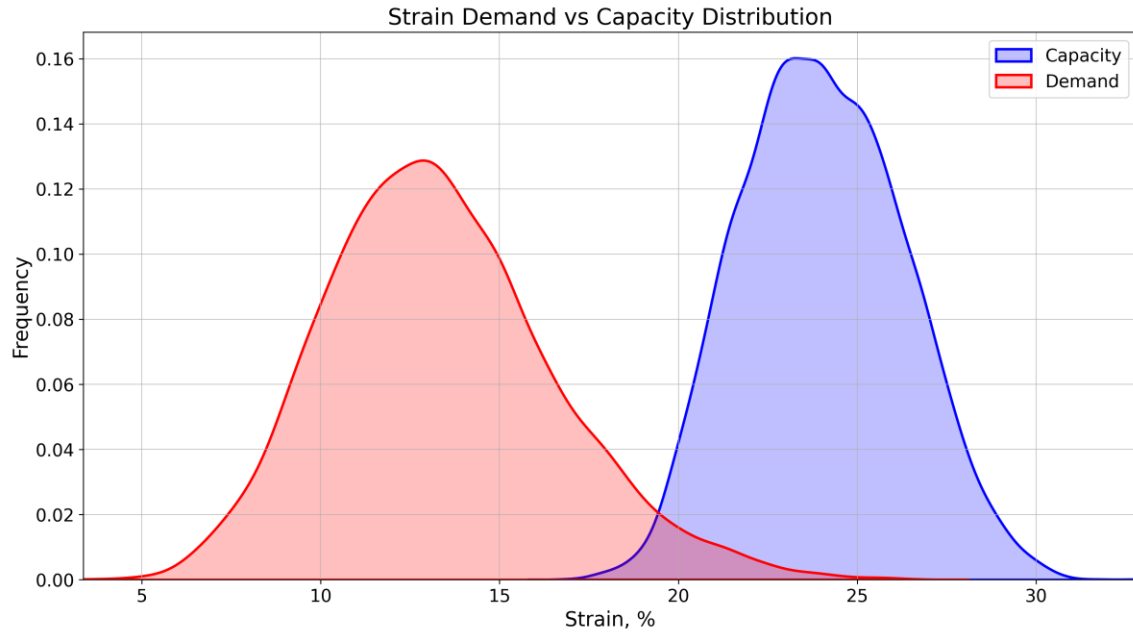
Figure 18: Strain demand and capacity distribution.

- Strain Demand (95th Percentile): **19.02 %**
- Strain Capacity (5th Percentile): **20.43 %**
- Strain Safety Factor: **1.07**
- Probability of Failure (PoF): **5.20E-03**

The calculated **strain safety factor of 1.07** is below the minimum required safety factor of 1.25 indicating that the feature does NOT meet the strain safety requirements.

The feature's strain probability of failure (PoF) is **5.20E-03**, which exceeds the required target of **1.00E-03**.

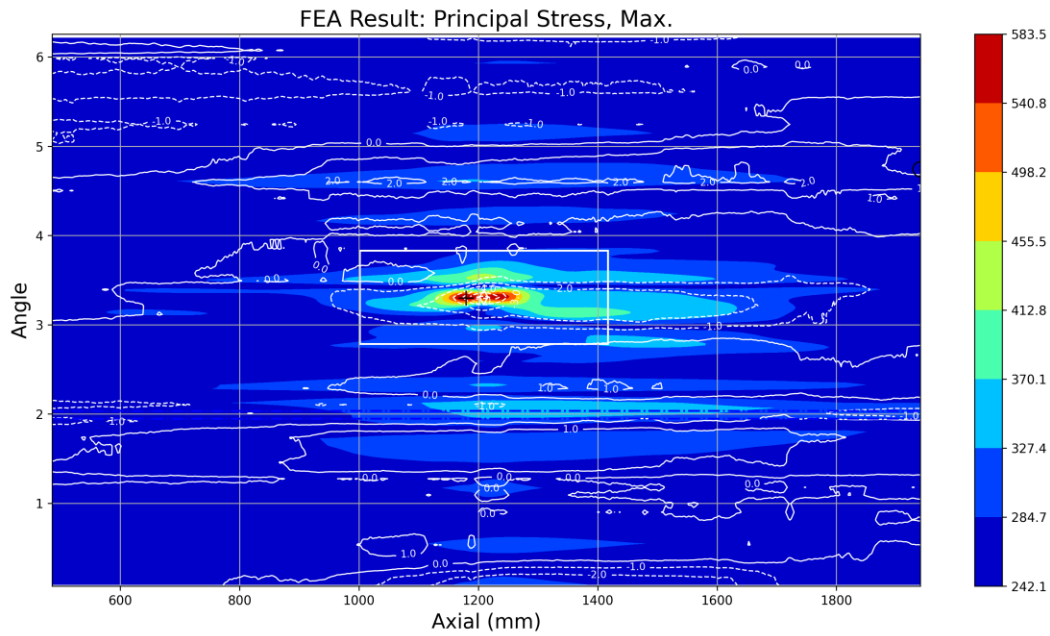
Figure 22: FEA Maximum Principal Stress.

Figure 22 presents the FEA maximum principal stress. The stress contour plot includes dent deformation contour lines overlaid on the maximum envelope stress through the pipe thickness. The extracted stress values at key locations are summarized below:

Location	Stress Value (MPa)
Maximum	583.53

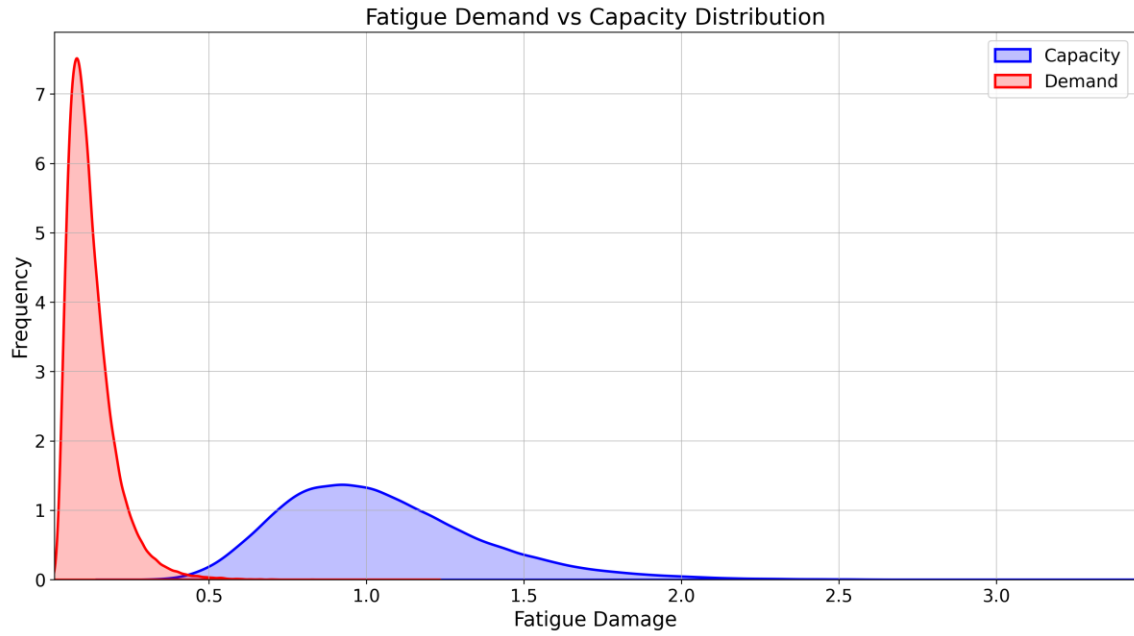
Figure 24: Fatigue damage demand and capacity distribution (Maximum).

Dent Age	Fatigue Stress	Fatigue, Demand	Fatigue, Capacity	Fatigue, Safety Factor	Fatigue, PoF	Fatigue, Remaining Damage	Location
72.00	583.53	0.25	0.60	2.44	1.47E-04	0.36	Maximum
77.00	583.53	0.27	0.60	2.28	2.21E-04	0.34	Maximum
72.00	583.53	0.25	0.60	2.44	1.47E-04	0.36	Feature
77.00	583.53	0.27	0.60	2.28	2.21E-04	0.34	Feature
