[F]IntegraFrame

Dent Screening Assessment Report

L00XX AB-CD

Feature: DNT 8, GW: 3225

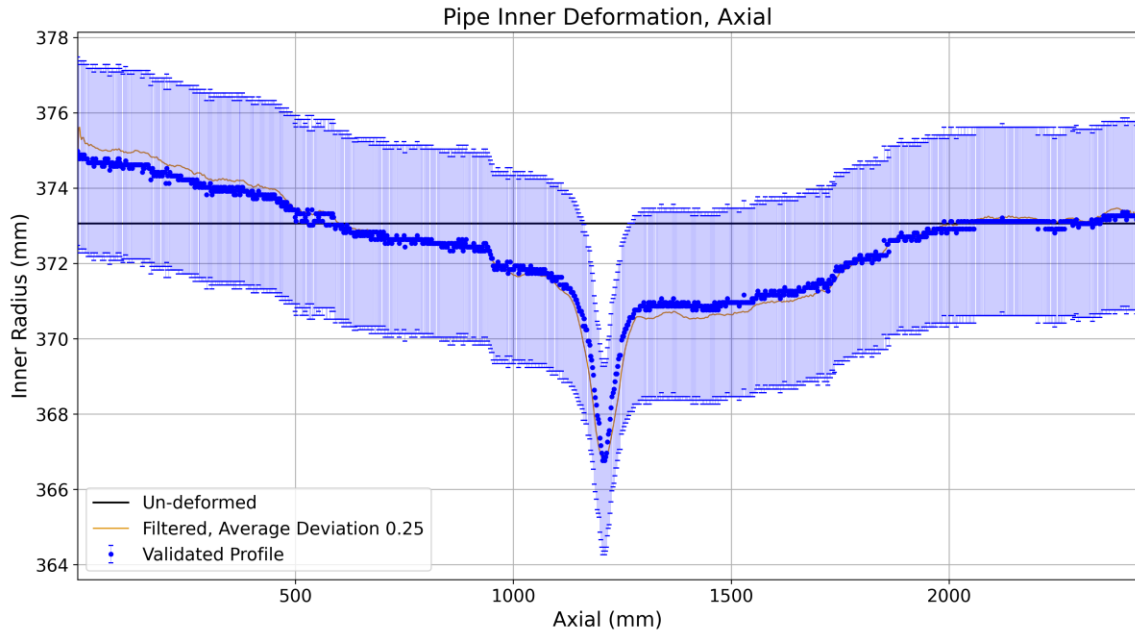
Figure 4: Filtered axial profile

The quantified average deviation between the provided and filtered axial profile is 0.25 mm

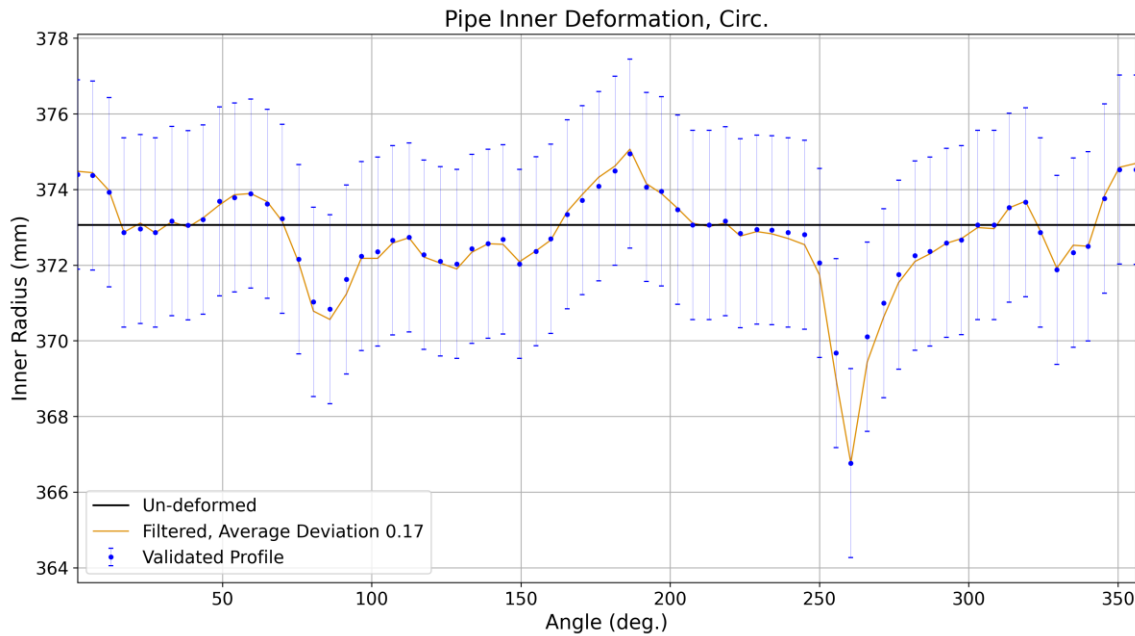
Figure 5: Filtered transverse profile

The quantified average deviation between the provided and filtered transverse profile is 0.17 mm

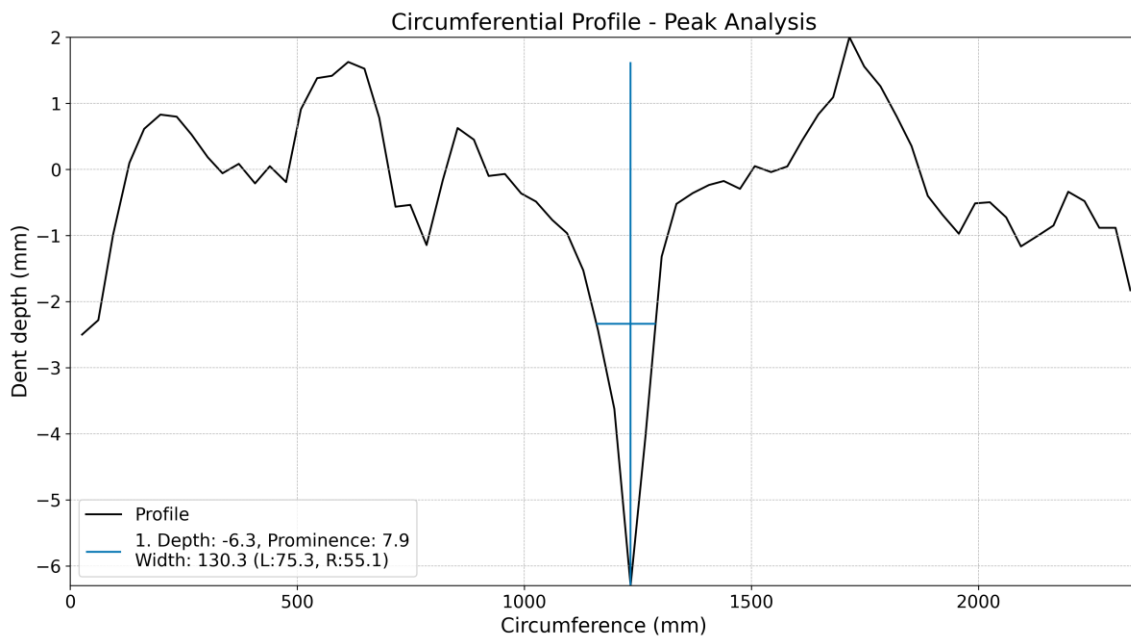
Figure 8: Transverse peak analysis plot

Note: Please verify the secondary transverse peak (refer to the transverse profile plot for confirmation)

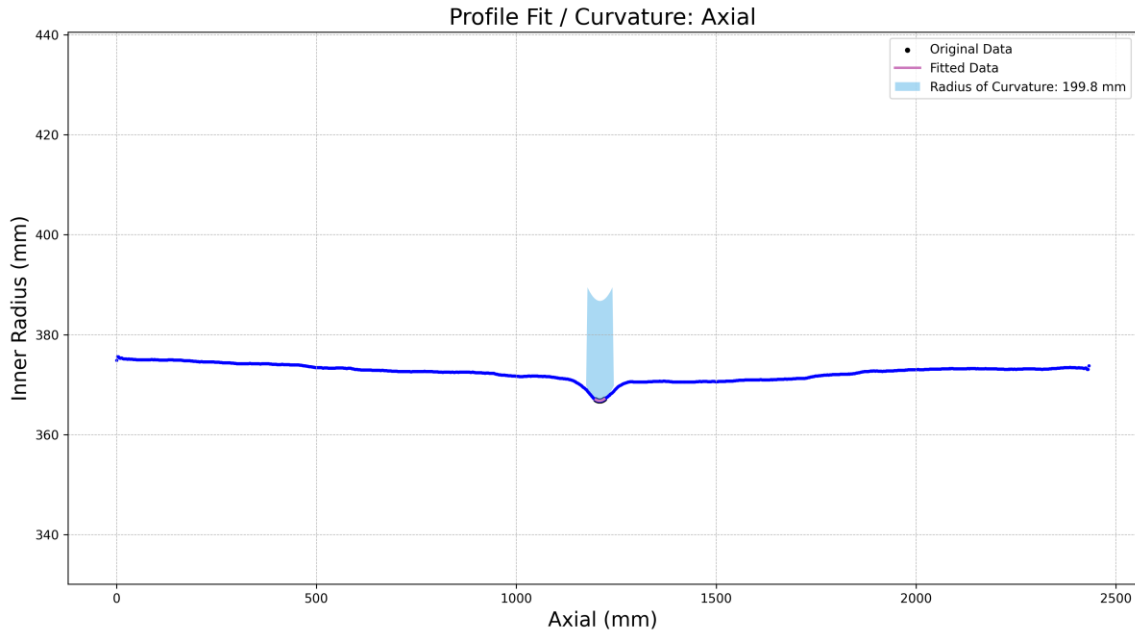
Figure 16: Axial curvature at the deepest point of the dent

The axial curvature at the deepest point of the dent feature is 199.78 mm. A curve-fitting equation was applied to the ILI profile data to calculate this curvature, achieving a fitting error of 0.01.

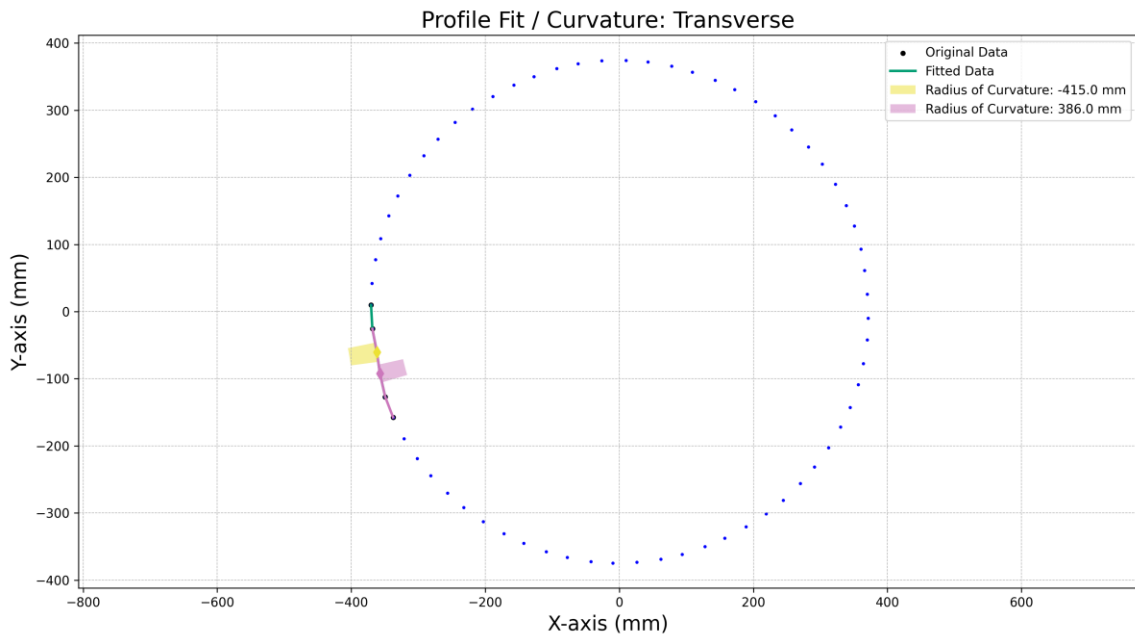
Figure 17: Transverse curvature at the deepest point of the dent

The transverse curvature at the deepest point of the dent feature is -414.98 mm. A curve-fitting equation was applied to the ILLI profile data to calculate this curvature, achieving a fitting error of 0.00

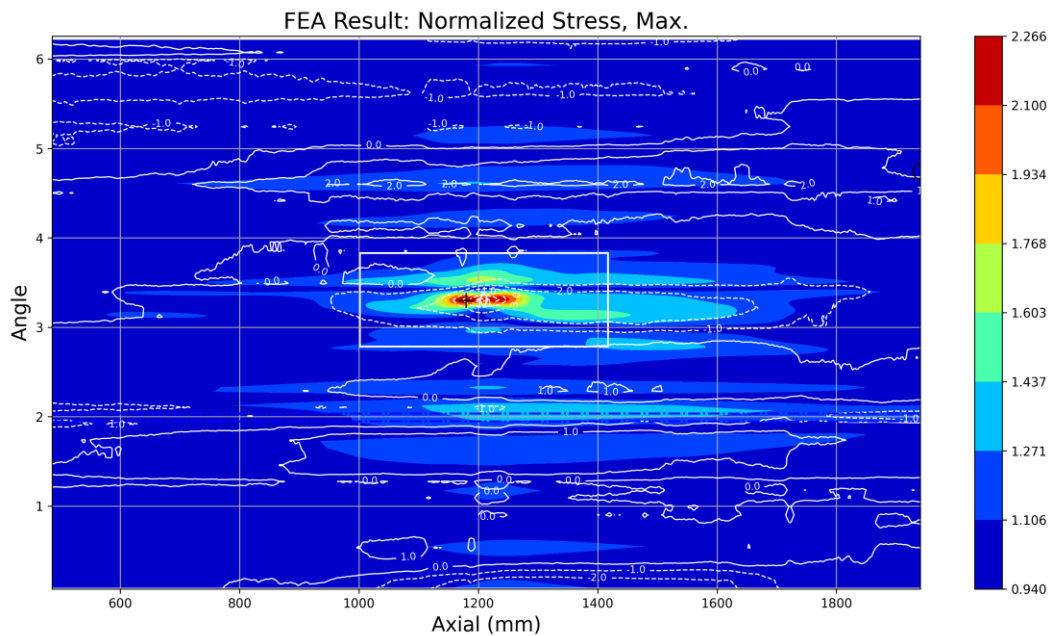
Figure 23: FEA Normalised Stress.

Figure 23 shows the normalized stress plot, which represents the ratio of the maximum principal stress to the corresponding nominal hoop stress.
